How to Access your cistern

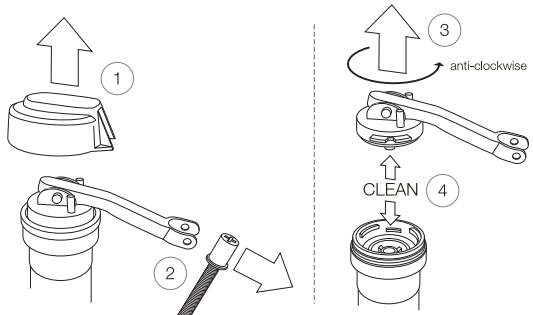
Problem	Potential cause	Suggested action
<p>The Fill Valve does not work or isn't controlling the water supply efficiently.</p>	<p>The flush valve may be blocked.</p>

<p>Follow the instructions below and clean the water inlet orifice and cap. If unsuccessful, replace the fill valve with a new one.</p>

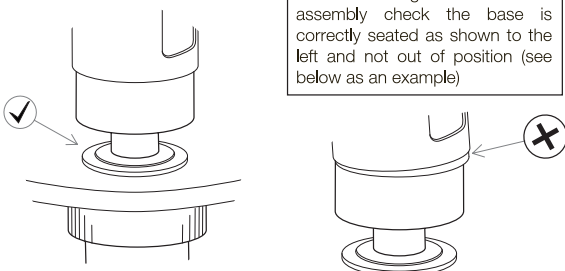
<p>Ensure the rubber gasket is fixed in position. However, If it's damaged a replacement is needed.</p> <div data-bbox="1204 1848 1492 1982" style="border: 1px solid black; padding: 5px;"> <p>NOTE: Before re-fitting the flush valve assembly check the base is correctly seated as shown to the left and not out of position (see below as an example)</p> </div>

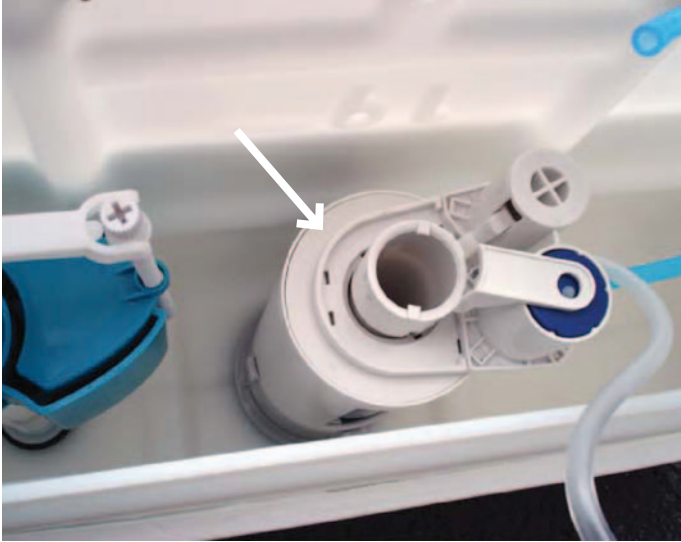
1

Check the flush valve mechanism is fitted as shown here and does not touch / interfere with the cistern casing.

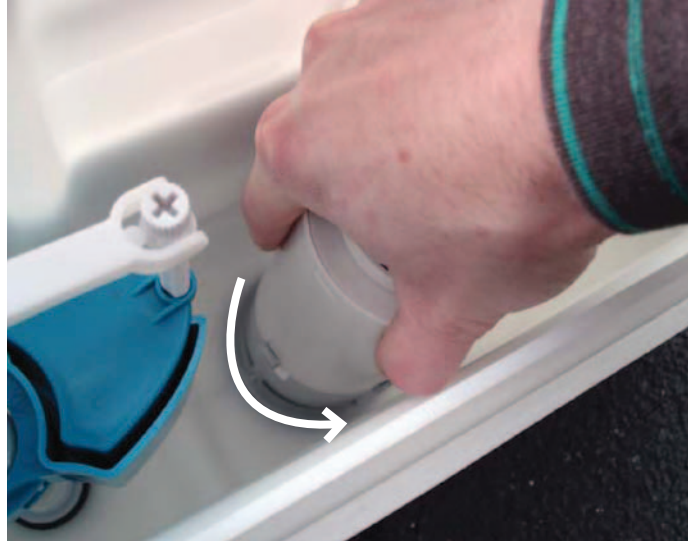
2

Remove the flush valve assembly by gripping the body and rotating anti-clockwise.

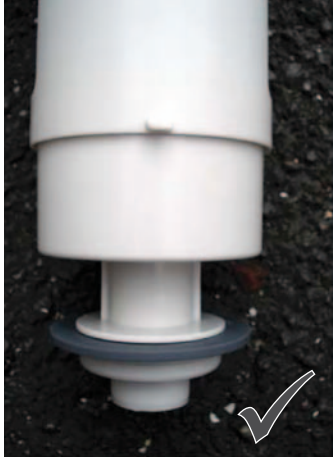
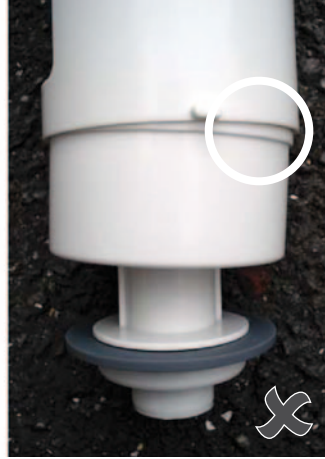
5

Before re-fitting the flush valve assembly check the base is correctly seated as shown. Also check there are no damaged (e.g. snapped) components.

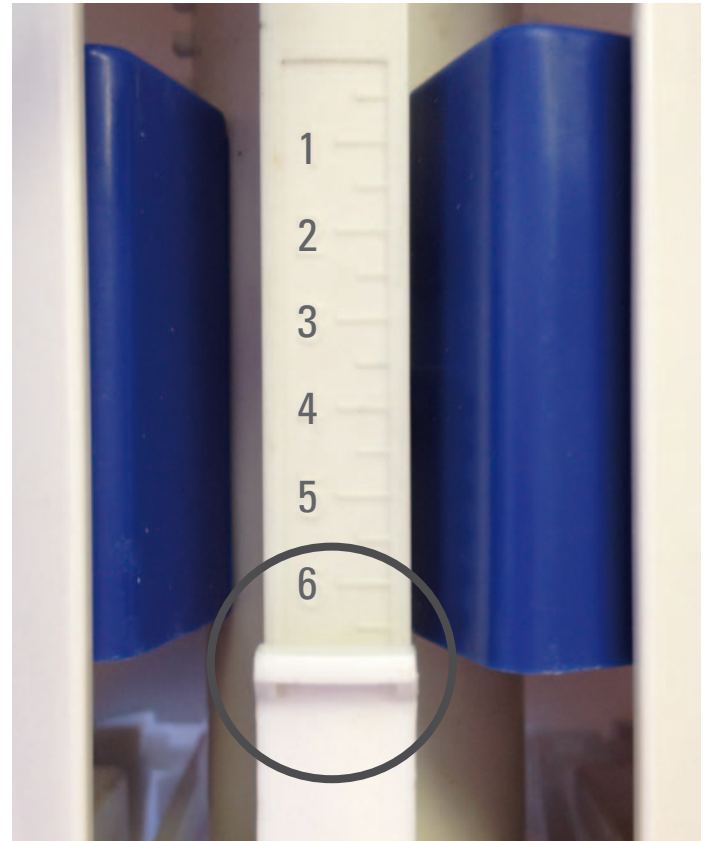
Large flush volume

The white plastic slider controls the large flush volume. This should be pre-set to between 6 and 7. Moving it further down increases the large flush volume and up decreases the large flush volume.
